# Manhole Inspection Summary

# Manhole # S11YY\_004MH

Insp Date: **7/31/07 1:18 PM**

**Location** Address: **3705 ELLAMONT RD**

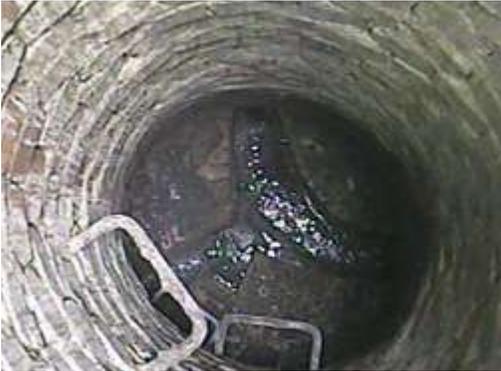
Top View

**Frame** Offset: **2** (in.)

OFFSET

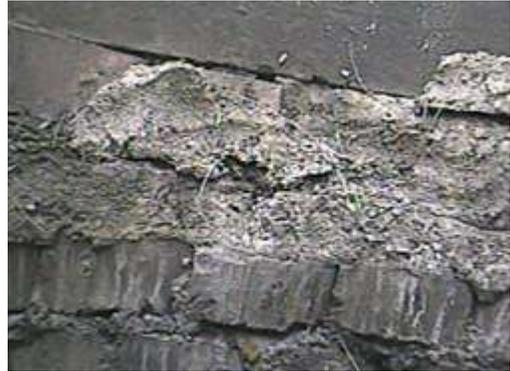
Defect 3

Condition:  Sound  **Cracked**  Root Intrusion  **Loose Brick**  Deteriorated

CRACKED CORBEL

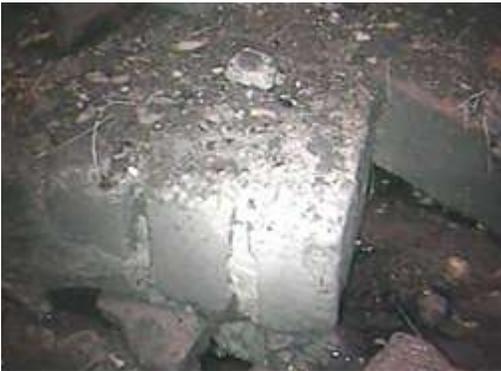
Defect 2

Condition:  Sound  Cracked  **Root Intrusion**  **Deteriorated**  Leaks  **Debris**

LOOSE BRICKS - BENCH

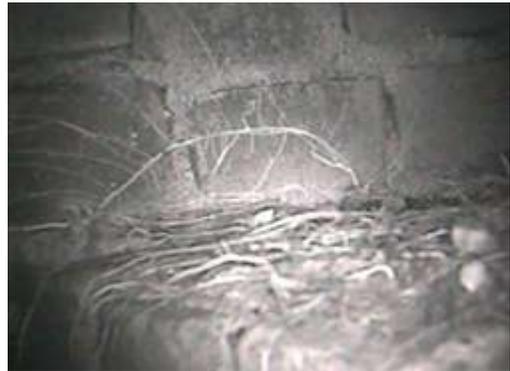
Defect 1

ROOT INFILTRATION - FINE- BENCH

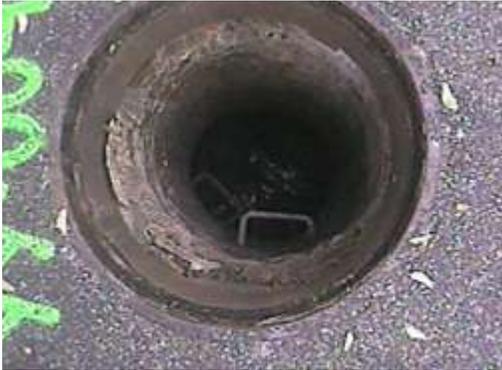
Defect 4

Condition:  Sound  Cracked  Root Intrusion  **Loose Brick**  Deteriorated

CHIMNEY/ADJUSTMENT LOOSE  
BRICKS

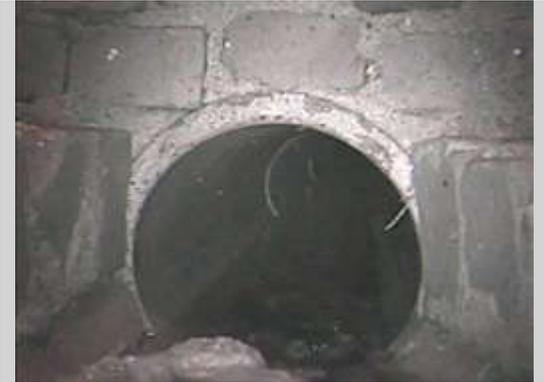
**12 O'Clock Outflow**

Pipe Height: (in.) Direct  
Pipe Material: **Clay**  Pipe Lined  
Invert Depth: **11.84** (ft.) Flow Characteristics: **Slow**  
Deposits:  None  Mud  Sludge  Debris  Grease  
Silt Depth: (in.) Deposits Extent:  
Infiltration: **None** Pipe Seal Cond: **Sound**

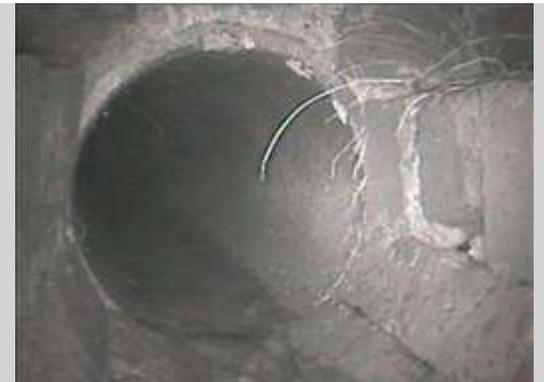
**4 O'Clock Inflow**

Pipe Height: (in.) Direct  
Pipe Material: **Clay**  Pipe Lined  
Invert Depth: **11.82** (ft.) Flow Characteristics: **Slow**  
Deposits:  None  Mud  Sludge  Debris  Grease  
Silt Depth: (in.) Deposits Extent:  
Infiltration: **None** Pipe Seal Cond: **Sound**

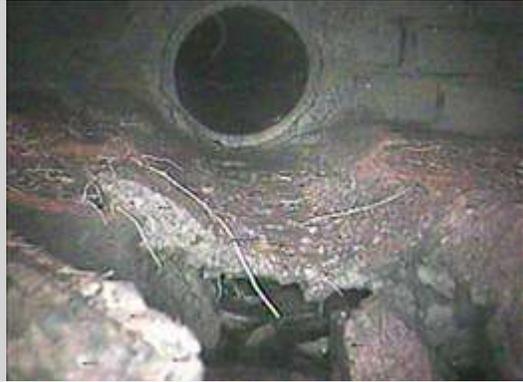
8 O'Clock Inflow

Pipe Material: **Clay**  Pipe Lined

Invert Depth: **11.64** (ft.) Flow Characteristics: **Slow**

Infiltration: **None** Pipe Seal Cond: **Sound**
